**CH-21A HELICOPTER AIRFRAME DEFORMATION  
UNDER A DYNAMIC CRASH CONDITION**

**Pertaining to the Dynamic Crash Test of a U. S. Army CH-21A Helicopter**

**January 1964**

TRECOM Technical Report 63-77

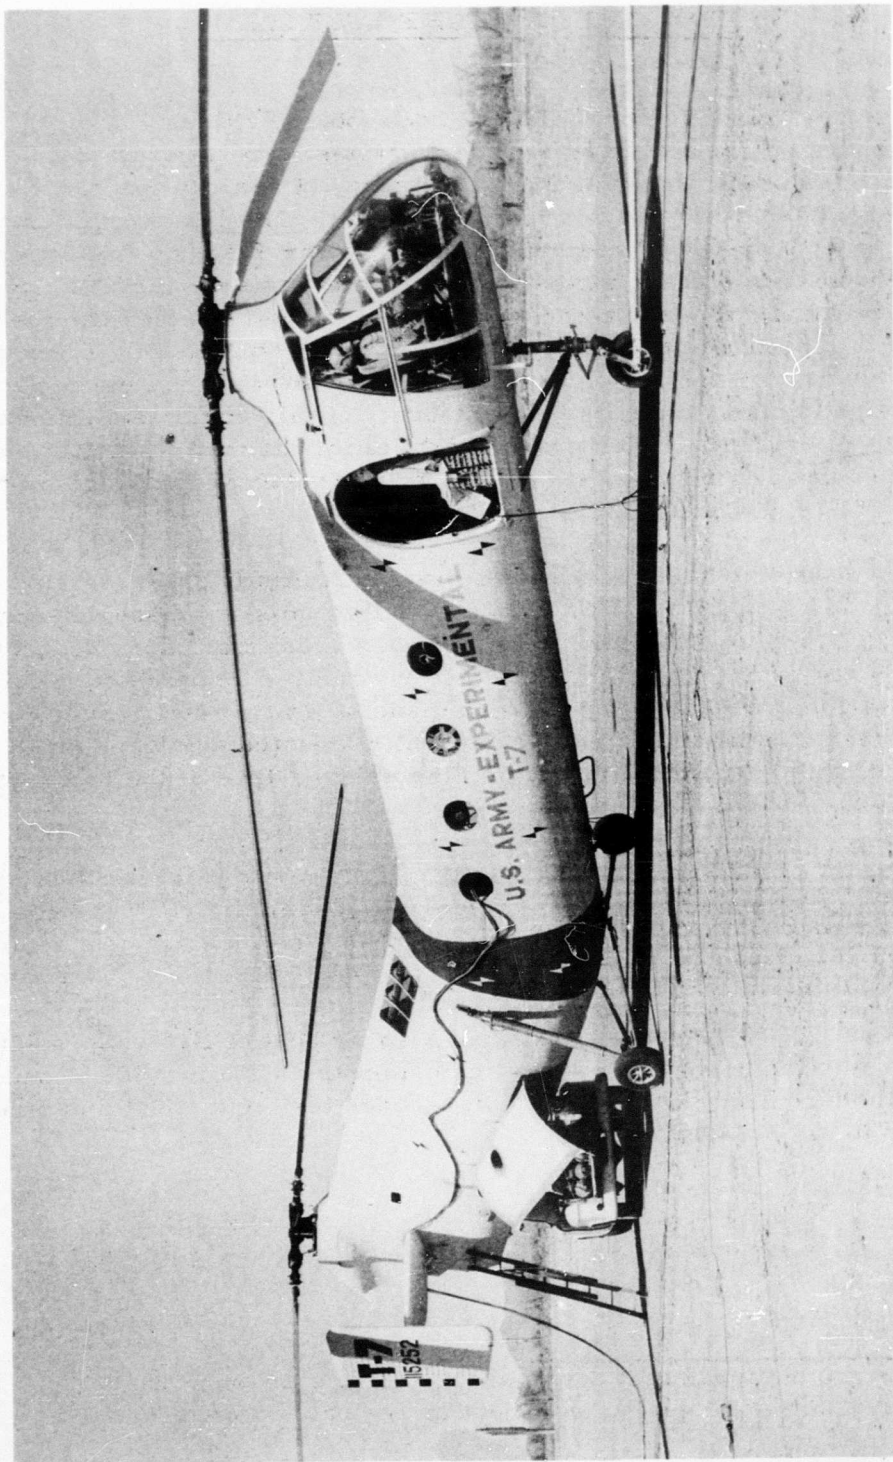
Figure 1. Test Vehicle Prior to Crash.

Note the various markings on the fuselage which aid in the study of structural deformation during crash.

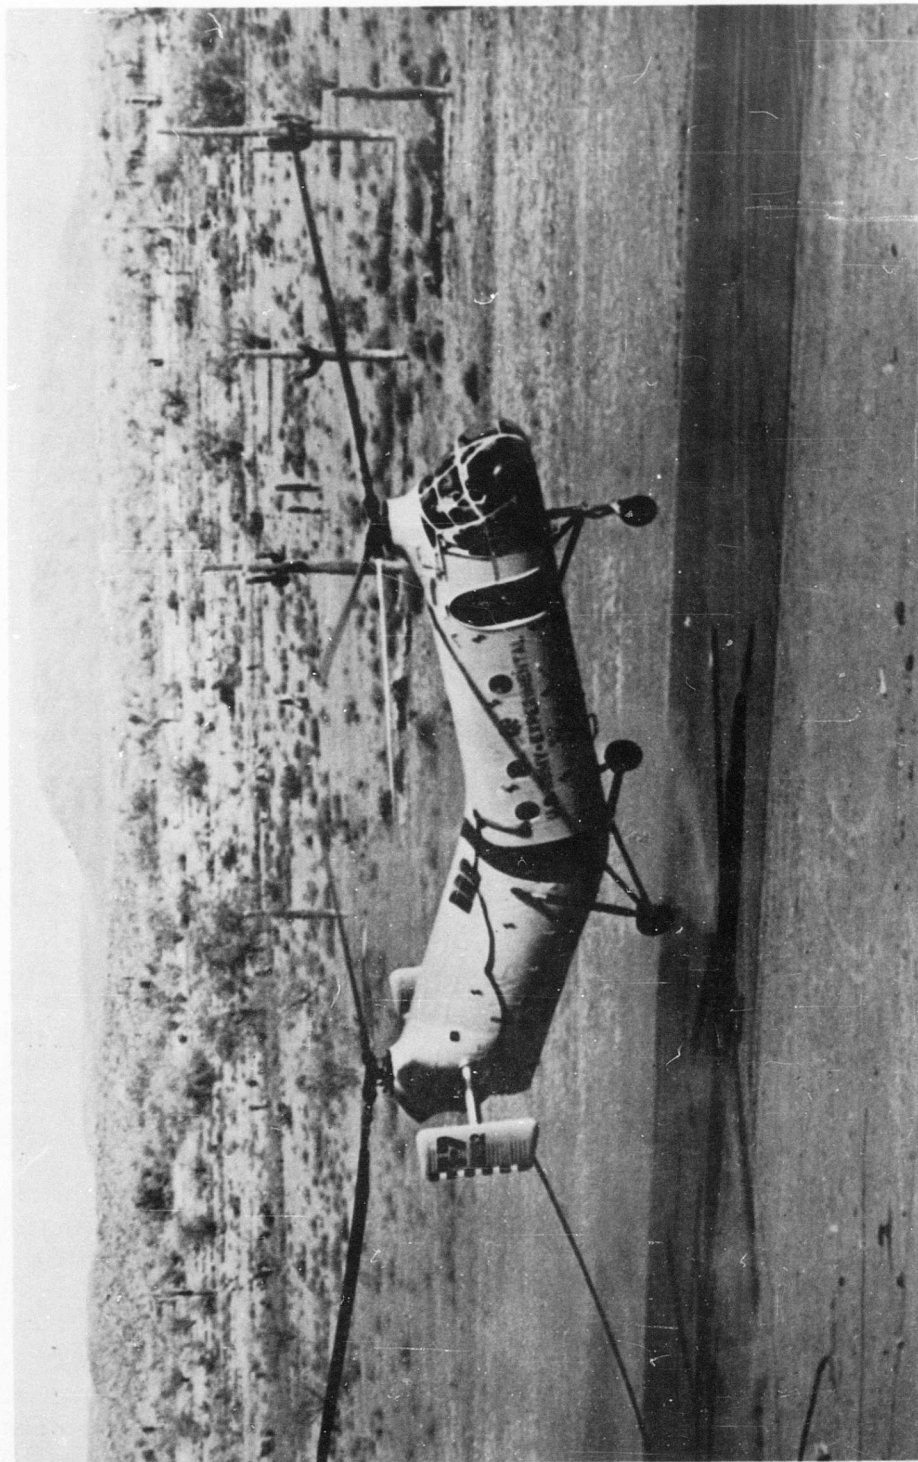
Figure 3. Test Vehicle Just After Lift-Off.

Note trailing umbilical cable through which all data were recorded during actual crash sequence.

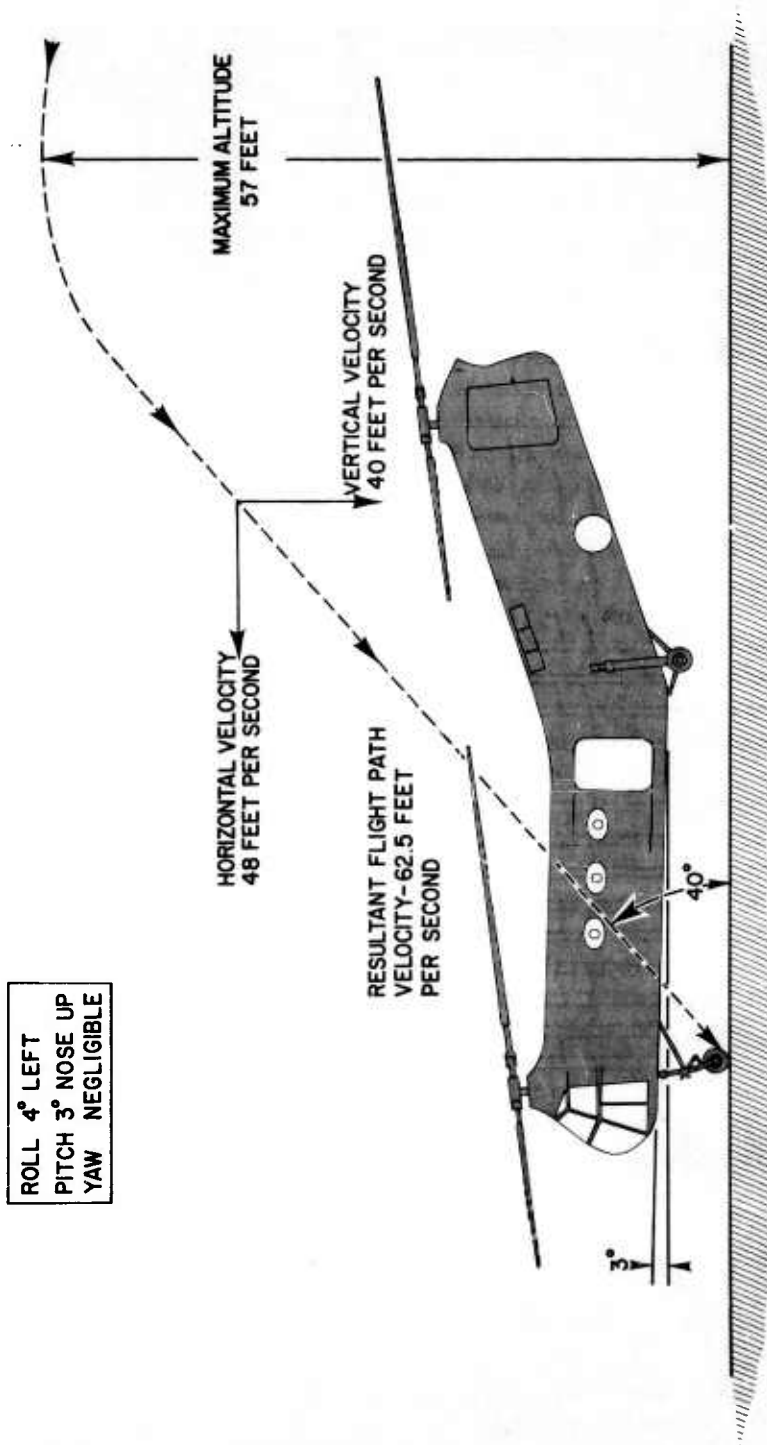
Figure 4. Crash Conditions of Altitude and Velocity.

The fuselage struck the runway 0.124 second after initial impact. At impact the lower structure of the forward fuselage section was crushed and the aft fuselage section was bent downward sufficiently to contact the runway. The right side of the fuselage skin ruptured vertically just aft of fuselage station 360 as the aft section bent downward. The aft fuselage section then rebounded, as shown in the action sequences of Figures 5, 6, and 7, and twisted to the left. The main fuel tank ruptured during this sequence of events, and liquid was observed spilling from the main fuel tank into the cargo compartment of the aircraft 0.370 second after initial impact as the aircraft skidded along the runway.

The entire cargo compartment lower body, including fuselage skin, floor support structure, and lower sections of body frames, was crushed by impact. Because the aircraft impacted with a slight left roll (Figure 4), the lower fuselage sustained more damage on the left side than on the right side.

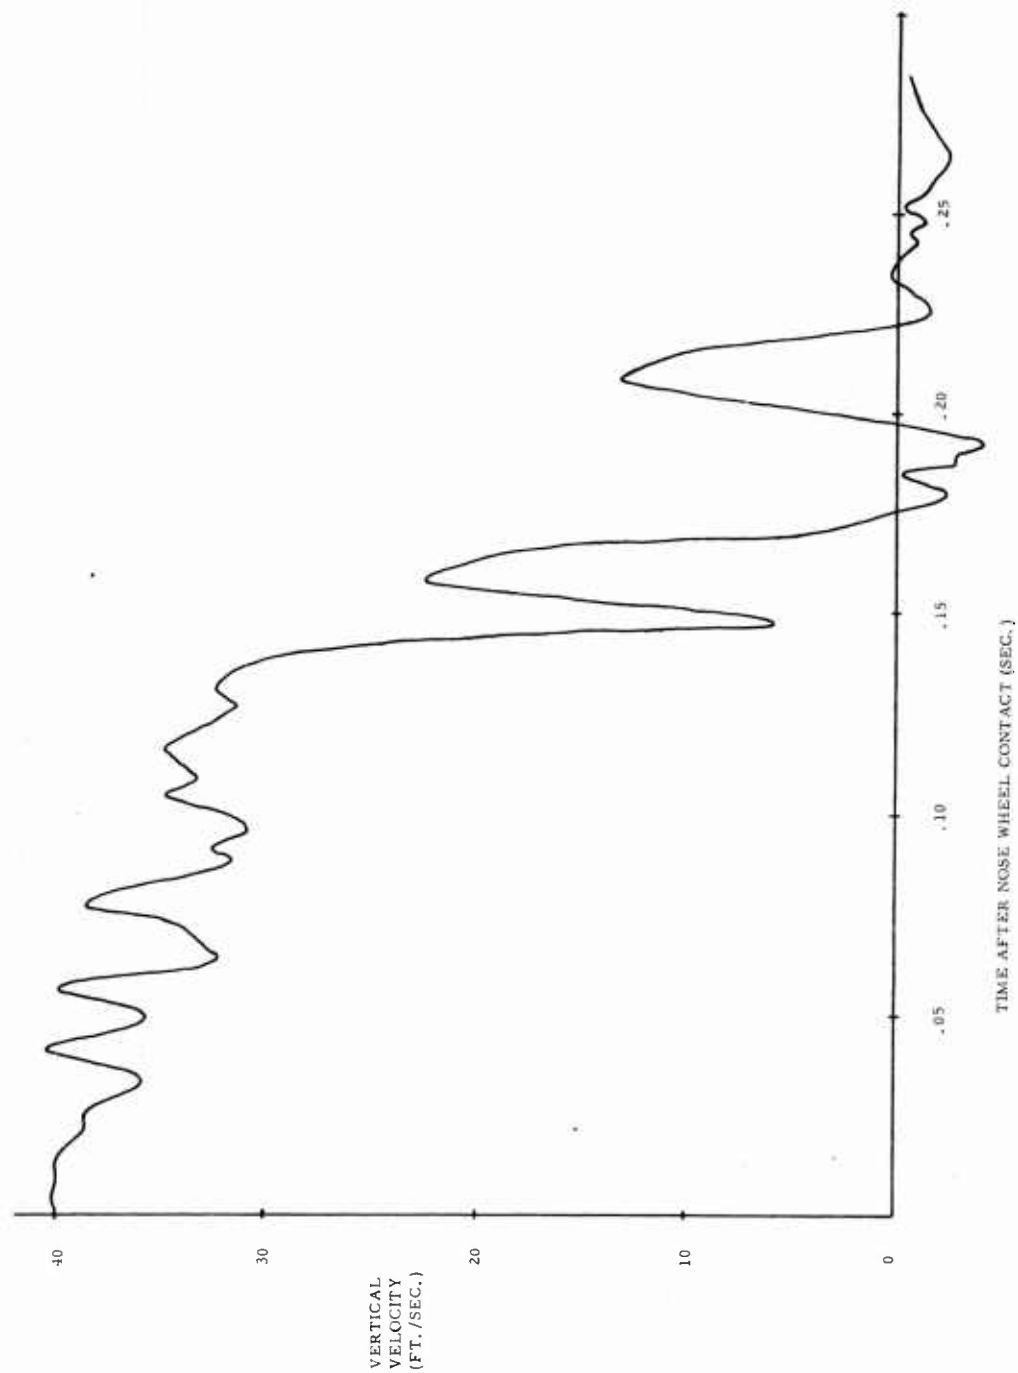
Figure 26. Vertical Velocity vs. Time, Cargo Compartment Floor.

The cargo compartment floor vertical accelerometer data were integrated to obtain the vertical velocity versus time curve of Figure 26. This curve shows a vertical velocity change at the end of 0.250 second of approximately 40.75 feet per second, which correlates closely with the vertical velocity of 40 feet per second which was obtained from the Fairchild Flight Analyzer data.

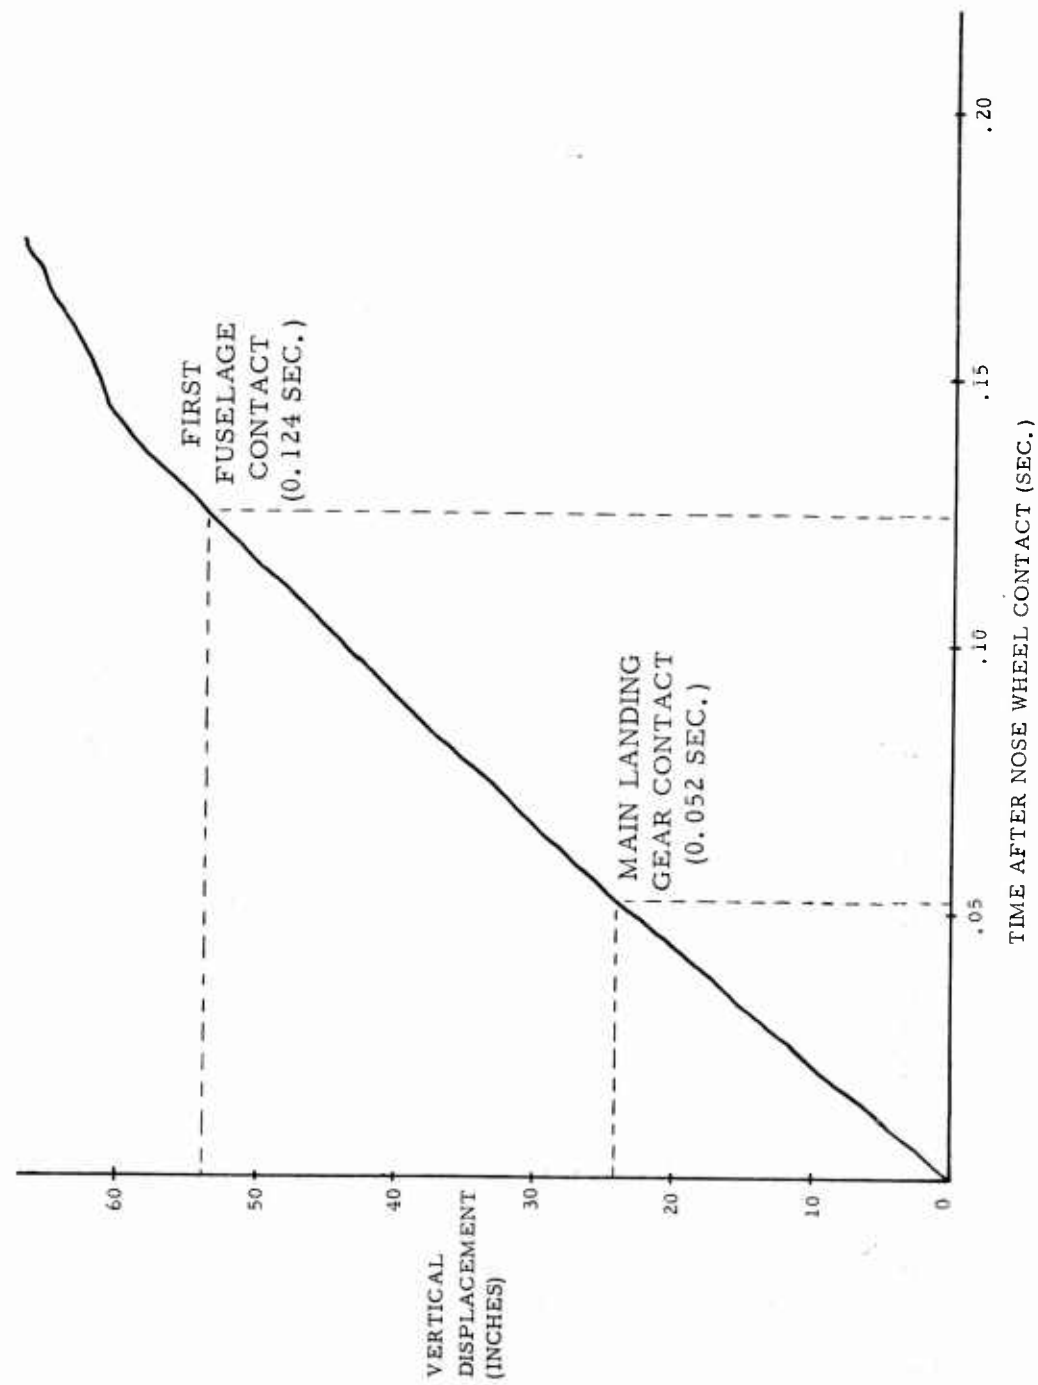
Figure 27. Vertical Displacement vs. Time, Cargo Compartment Floor.

With a CH-21A in the same attitude as the crash attitude, the vertical distance between the bottom of the nose gear and the bottom of the main gear is approximately 24.5 inches. The distance between the bottom of the main gear and the bottom of the fuselage at the point where the fuselage contacted the ground is approximately 29.0 inches, and the vertical distance between the bottom of the fuselage and the cargo compartment floor at the location of the accelerometer, fuselage station 270, is approximately 18 inches. Thus, the total possible vertical displacement of this accelerometer was approximately 70.5 inches. The difference between the computed vertical displacement and this maximum measured value is 4.65 inches. Postcrash observation placed the floor of the fuselage approximately 5 inches above the runway at the location of the accelerometer mount. The close correlation of both velocity change information and vertical displacement data as obtained from two separate sources is added proof of the validity of this accelerometer data.
